**Flood Control Project Maintenance
Levee Inspections**
LMA District Cover Sheet
Spring 2018 Levee Inspection Results

Reclamation District No. 0999 Netherlands

Spring 2018 Levee Inspection Results

Waterway			Bank	Unit Miles
Unit No. 01 Yolo Bypass			Left	15.41
	Spring (March - May)	Summer (June - August)	(September - November) Fall	Winter (December - February)
Unit Maintenance Rating (Fall Only)				
Date of Inspection	5/8/2018 - 5/8/2018			
DWR Inspector	Dave Torres			
Accompanied By	Tom Slater RD999

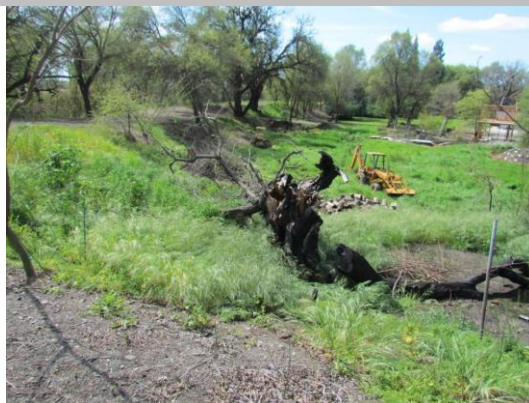
Photo 2 of 2 : SP_2018_RD0999_235_45_20180301_00035.jpg

LM Start	0.03	Rating **	M	Issue No.	45 (cont)
LM End	0.03	Issue Type +	Ma	Location *	LS

Looking west at fallen tree on landward slope.

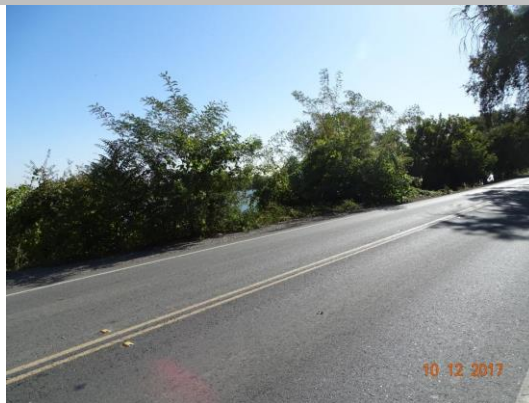
Photo 1 of 1 : SP_2018_RD0999_235_53_20180301_00042.jpg

LM Start	0.04	Rating **	U	Issue No.	53
LM End	0.06	Issue Type +	Ma	Location *	WS
Category	Earthen Levee			GPS Latitude/Longitude	
				Start	End
Item	Vegetation			38.414533 °	38.414750 °
				-121.523394 °	-121.523543 °
DWR ID	DWR_RD0999_04_f_2017_53				
Comment Code					
V2 : Remove the wild growth other than native grasses from the levee slopes.					
Inspector Comment					
Dense vegetation on waterside slope.

Looking southeast at the waterside slope.

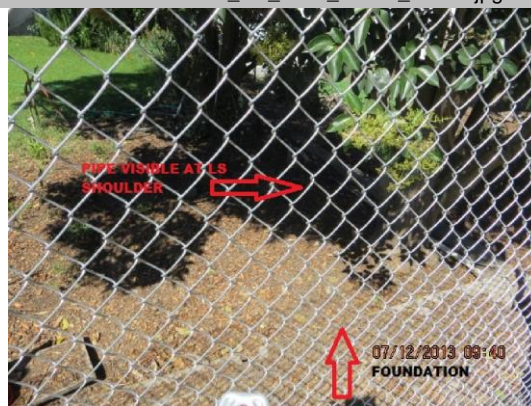
Photo 1 of 3 : UCIP_SP_2018_15709_26140.jpg

Comment Code					
Inspector Comment					
FS_ID:15709 DS_ID:22789 EP_NO: N/A Repair Type: Non-Urgent Crossing Status: Found UCIP Comments: Pipe abandoned and should be done so properly. FIELD_STRUCT_DESC: *ABANDONED* 2-inch steel pipe of unknown purpose through the levee, 4.5 feet below the crown. Concrete blocks for missing pump and pressure system visible on the waterside (WS) slope. 8-inch steel standpipe on the WS toe with remnants of the 2-inch pipe visible at the top. Pipe visible at concrete foundation on the landside (LS) shoulder. [Additional Reference(s): DWR Levee Log, 1992. USACE Sacramento O&M Manual 113 (Revised), October 1966, (HLM 0.02)]. FS Date: 7/12/2013

Pipe visible at concrete foundation on LS shoulder.

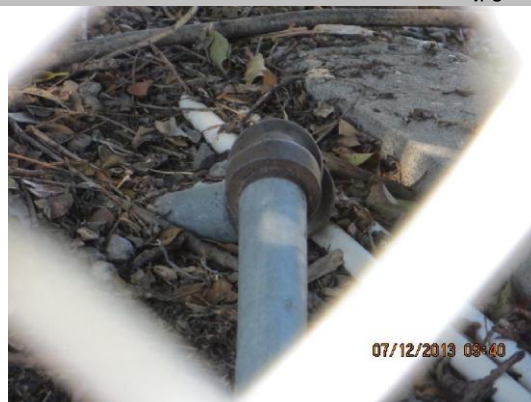
Photo 2 of 3 : UCIP_SP_2018_15709_26139.jpg

Pipe visible at concrete foundation on LS shoulder.

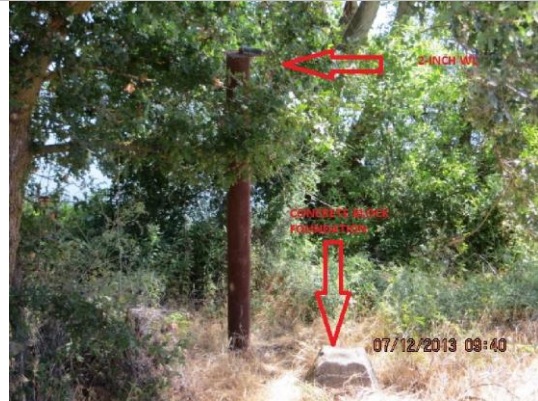
Photo 3 of 3 : UCIP_SP_2018_15709_26138.jpg

Comment Code						
Inspector Comment						
FS_ID:15709 DS_ID:22789 EP_NO: N/A Repair Type: Non-Urgent Crossing Status: Found UCIP Comments: Pipe abandoned and should be done so properly. FIELD_STRUCT_DESC: *ABANDONED* 2-inch steel pipe of unknown purpose through the levee, 4.5 feet below the crown. Concrete blocks for missing pump and pressure system visible on the waterside (WS) slope. 8-inch steel standpipe on the WS toe with remnants of the 2-inch pipe visible at the top. Pipe visible at concrete foundation on the landside (LS) shoulder. [Additional Reference(s): DWR Levee Log, 1992. USACE Sacramento O&M Manual 113 (Revised), October 1966, (HLM 0.02)]. FS Date: 7/12/2013

Pipe visible at top of steel standpipe. Foundation for pump station visible on WS slope.

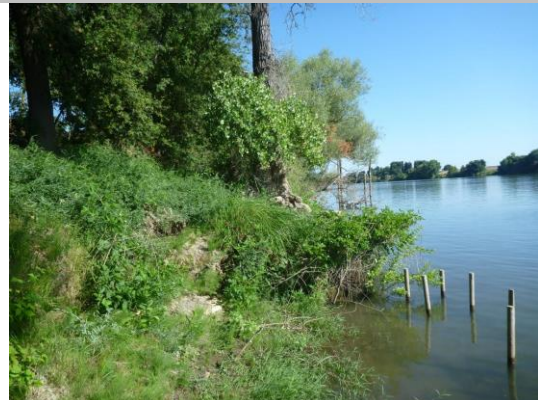
Photo 1 of 3 : LEVAL_SP_2018_357_2461.jpg

LM Start	0.10	Rating **	A/W	Issue No.	42
LM End	0.29	Issue Type +	Ma	Location *	
Category	Supplemental			GPS Latitude/Longitude	
				Start	End
Item	2017 Storm Damage			38.415319 °	38.417744 °
				-121.523717 °	-121.525344 °
DWR ID	DWR_RD0999_04_f_2017_42				
Comment Code					
Inspector Comment					
Levee Evaluation Comments					
Description:The damage consists of erosion of the lower and mid waterside levee slope approximately 997 feet in length along the west (right) bank of the Sacramento River. See attached pages for photos. Site location T06N R04E Section 3 and 4.					
Site ID No:357					
Site Designation:LMA-184					
Repair Type: Erosion					
Rating:Serious					
Field Date:7/27/2017					
Notes: on bank slope, big trees with exposed tree roots observed

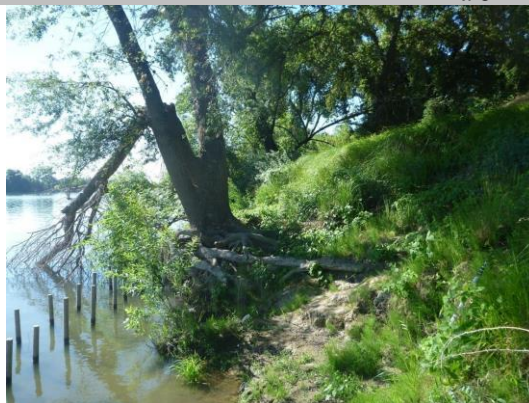
Photo 2 of 3 : LEVAL_SP_2018_357_2465.jpg

LM Start	0.10	Rating **	A/W	Issue No.	42 (cont)
LM End	0.29	Issue Type +	Ma	Location *	
Category	Supplemental			GPS Latitude/Longitude	
				Start	End
Item	2017 Storm Damage			38.415319 °	38.417744 °
				-121.523717 °	-121.525344 °
DWR ID	DWR_RD0999_04_f_2017_42				
Comment Code					
Inspector Comment					
Levee Evaluation Comments					
Description:The damage consists of erosion of the lower and mid waterside levee slope approximately 997 feet in length along the west (right) bank of the Sacramento River. See attached pages for photos. Site location T06N R04E Section 3 and 4.					
Site ID No:357					
Site Designation:LMA-184					
Repair Type: Erosion					
Rating:Serious					
Field Date:7/27/2017					
Notes: on bank slope, big trees with exposed tree roots observed

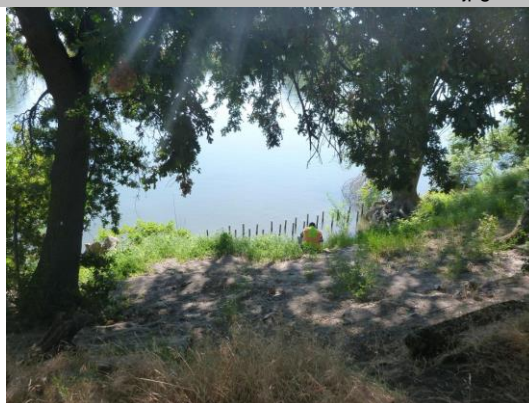
Photo 3 of 3 : LEVAL_SP_2018_357_2475.jpg

LM Start	0.10	Rating **	A/W	Issue No.	42 (cont)
LM End	0.29	Issue Type +	Ma	Location *

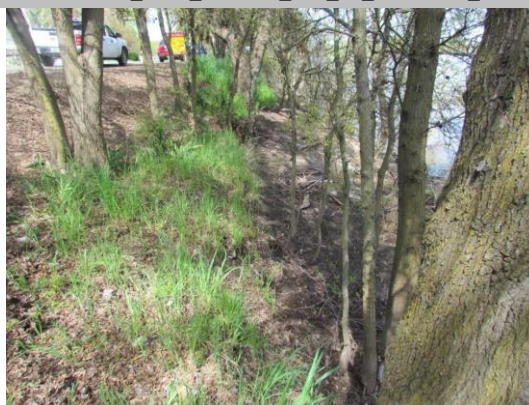
Photo 2 of 2 : SP_2018_RD0999_235_15_20180301_00013.jpg

LM Start	0.11	Rating **	A/W	Issue No.	15
LM End	0.21	Issue Type +	Ma	Location *	WS
Category	Earthen Levee			GPS Latitude/Longitude	
				Start	End
Item	Erosion / Bank Caving			38.415425 °	38.416733 °
				-121.523920 °	-121.524705 °
DWR ID	DWR_RD0999_04_s_2017_15				
Comment Code					
E2 : Schedule repair of erosion site prior to the next inspection.					
Inspector Comment					
Waterside erosion 2ft vertical cut.

Looking upstream at 2ft plus vertical erosion on waterward slope.

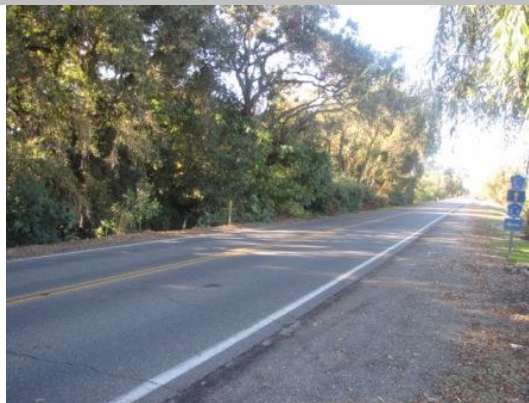
Photo 2 of 2 : SP_2018_RD0999_235_12_20180301_00010.jpg

LM Start	0.31	Rating **	U	Issue No.	12 (cont)	
LM End	0.35	Issue Type +	En	Location *	LS	
Category	Earthen Levee			GPS Latitude/Longitude		
				Start		End
Item	Vegetation			38.417962 °		38.418449 °
				-121.525709 °		-121.526015 °
DWR ID	DWR_RD0999_04_s_2012_12					
Comment Code						
V6 : Landscaping						
Inspector Comment

Looking northwest at dense vegetation on landside shoulder and slope.

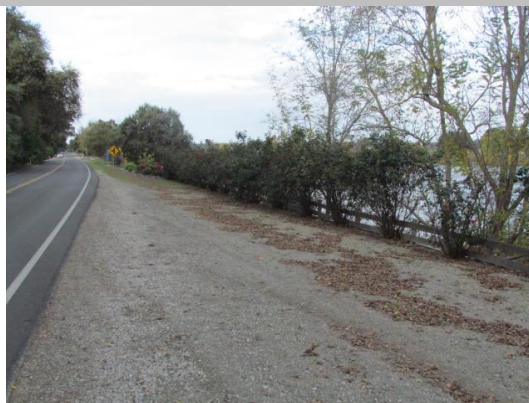
Photo 1 of 1 : SP_2018_RD0999_235_1_20180301_00001.jpg

LM Start	0.36	Rating **	M	Issue No.	1
LM End	0.47	Issue Type +	En	Location *	WS
Category	Earthen Levee			GPS Latitude/Longitude	
				Start	End
Item	Vegetation			38.418593 °	38.420004 °
				-121.526024 °	-121.526962 °
DWR ID	DWR_RD0999_04_s_2012_1				
Comment Code					
V6 : Landscaping					
Inspector Comment

Looking north at rose bushes on waterside slope.

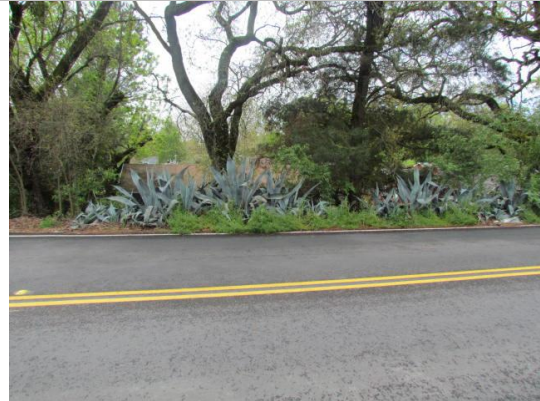
Photo 2 of 2 : SP_2018_RD0999_235_11_20180301_00008.jpg

LM Start	0.38	Rating **	U	Issue No.	11 (cont)	
LM End	0.50	Issue Type +	En	Location *	LS	
Category	Earthen Levee			GPS Latitude/Longitude		
				Start	End	
Item	Vegetation			38.418871 °	38.420451 °	
				-121.526257 °	-121.527386 °	
DWR ID	DWR_RD0999_04_s_2012_11					
Comment Code						
V6 : Landscaping						
Inspector Comment

Looking west at century plants on landside shoulder and slope.

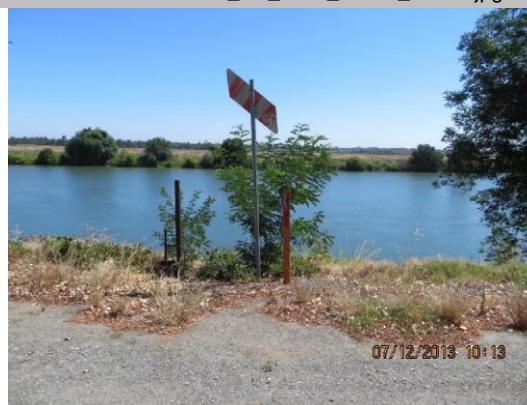
Photo 1 of 3 : UCIP_SP_2018_15712_26150.jpg

LM Start	0.71	Rating **	M	Issue No.	56
LM End	0.71	Issue Type +	En	Location *	
Category	Supplemental			GPS Latitude/Longitude	
				Start	End
Item	DWR UCIP Field Study			38.423062 °	38.423062 °
				-121.529241 °	-121.529241 °
DWR ID					
Comment Code					
Inspector Comment					
FS_ID:15712					
DS_ID:22791					
EP_NO: 3973					
Repair Type: Non-Urgent					
Crossing Status: Found					
UCIP Comments: Slide gate broken on LS toe. Appears it may be abandoned.					
FIELD_STRUCT_DESC: 18-inch steel drainage pipe through the levee, 4.7 feet below the crown. Air vent in an 18-inch steel standpipe on the waterside (WS) shoulder. Gate valve on the landside (LS) toe. (Permit No. 3973, 1962 - American Crystal Sugar Company). [Additional Reference(s): DWR Levee Log, 1992. USACE Sacramento O&M Manual 113 (Revised), October 1966, (HLM 0.71)].					
FS Date: 7/12/2013

Air vent in standpipe on WS shoulder.

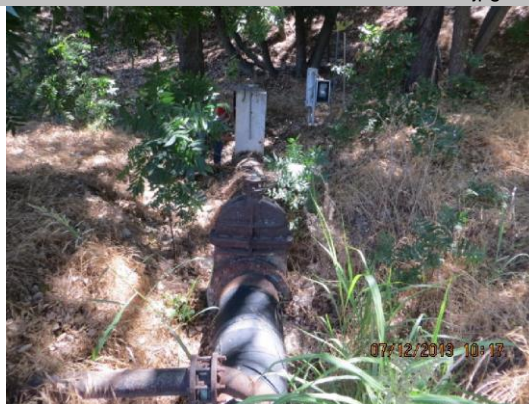
Photo 3 of 3 : UCIP_SP_2018_15712_26148.jpg

Gate valve on LS toe.

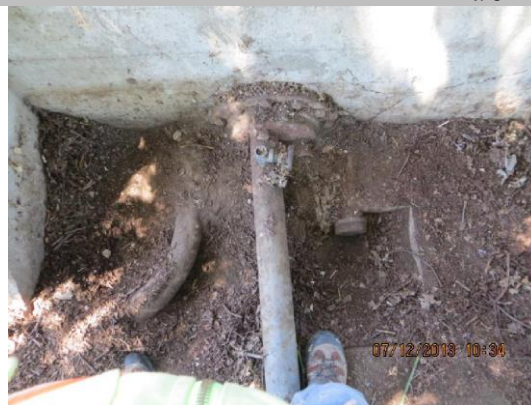
Photo 2 of 3 : UCIP_SP_2018_15725_26180.jpg

Siphon breaker at headwall on WS.

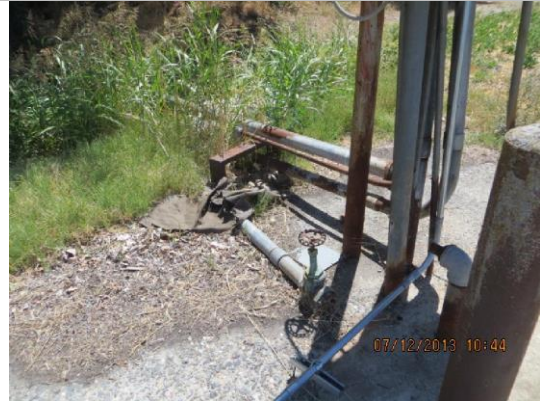
Photo 3 of 3 : UCIP_SP_2018_15725_26179.jpg

Pipe with gate valve off LS toe.

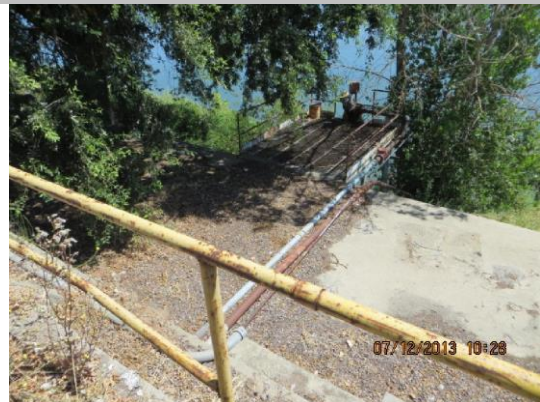
Photo 1 of 3 : UCIP_SP_2018_41556_26160.jpg

LM Start	0.74	Rating **	M	Issue No.	58
LM End	0.74	Issue Type +	En	Location *	
Category	Supplemental			GPS Latitude/Longitude	
				Start	End
Item	DWR UCIP Field Study			38.423429 °	38.423429 °
				-121.529491 °	-121.529491 °
DWR ID					
Comment Code					
Inspector Comment					
FS_ID:41556					
DS_ID:22794					
EP_NO: N/A					
Repair Type: Non-Urgent					
Crossing Status: Found					
UCIP Comments: Good candidate for video inspection.					
FIELD_STRUCT_DESC: 10-inch steel conduit of an unknown purpose through the levee, 3.8 feet below the crown. 4.5-inch galvanized iron pipe sleeved through the 10-inch conduit with annular space grouted.					
[Additional Reference(s): DWR Levee Log, 1992. USACE Sacramento O&M Manual 113 (Revised), October 1966, (HLM 0.73)].					
FS Date: 7/12/2013

Pump on pier for 4.5-inch pipe sleeved through 10-inch.

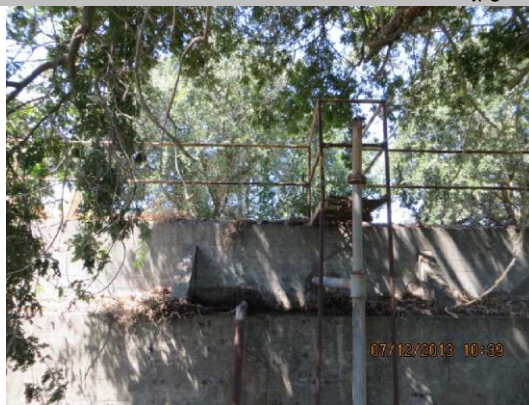
Photo 3 of 3 : UCIP_SP_2018_41556_26158.jpg

4.5-inch pipe at headwall on WS slope.

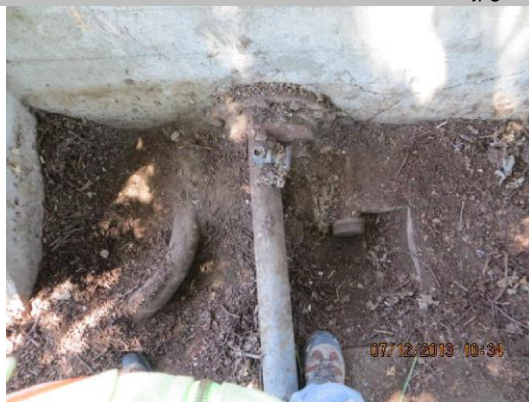
Photo 2 of 2 : UCIP_SP_2018_41535_26166.jpg

3.5-inch electrical conduit shown at left of 10-inch pipe.

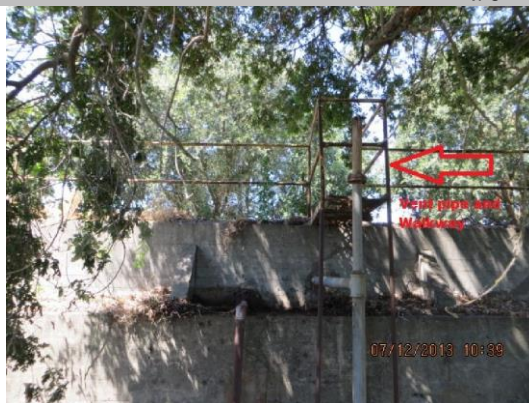
Photo 2 of 3 : UCIP_SP_2018_41070_26173.jpg

LM Start	0.74	Rating **	M	Issue No.	60	
LM End	0.74	Issue Type +	En	Location *		
Category	Supplemental			GPS Latitude/Longitude		
				Start	End	
Item	DWR UCIP Field Study			38.423429 °	38.423429 °	
				-121.529491 °	-121.529491 °	
DWR ID						
Comment Code						
Inspector Comment						
FS_ID:41070						
DS_ID:22811						
EP_NO: 10514						
Repair Type: Non-Urgent						
Crossing Status: Found						
UCIP Comments: Need to determine disposition of pipe and if abandoned, it should be done so properly.						
FIELD_STRUCT_DESC: 2 of 3: 4.5-inch galvanized iron irrigation pipe through the levee, 3 feet below the crown. Slant pump, steel walkway, and steel vent pipe on the waterside (WS) slope. Shutoff valve off the landside (LS) toe. (Permit No. 10514, 1975 - The Newhall Land and Farming Company). [Additional Reference(s): DWR Levee Log, 1992].						
FS Date: 7/12/2013

Pipe, walkway, and vent on WS shoulder.

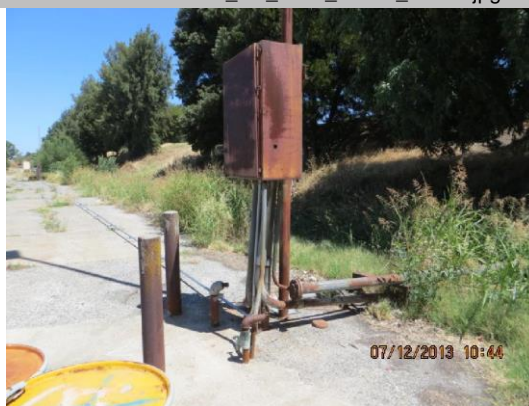
Photo 3 of 3 : UCIP_SP_2018_41070_26175.jpg

Pipe with cap or gate valve on end off LS toe.

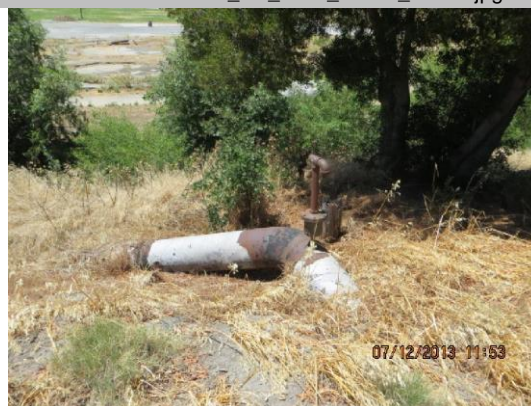
Photo 2 of 2 : UCIP_SP_2018_16389_27668.jpg

Comment Code						
Inspector Comment						
FS_ID:16389						
DS_ID:22797						
EP_NO: 1624						
Repair Type: Non-Urgent						
Crossing Status: Found						
UCIP Comments: Pipe abandoned and should be done so properly.						
FIELD_STRUCT_DESC: 16-inch steel irrigation pipe through the levee,						
3 feet below the crown. Pump and pile structure removed from the						
waterside (WS) toe. Steel plate welded over the WS end. (Permit No.						
1624, 1951 - American Crystal Sugar Company. Replaces an existing						
facility north of this location). [Additional Reference(s): DWR Levee Log,						
1992. USACE Sacramento O&M Manual 113 (Revised), October 1966,						
(HLM 0.81)].						
FS Date: 7/12/2013

Pipe and vent/siphon breaker on LS slope.

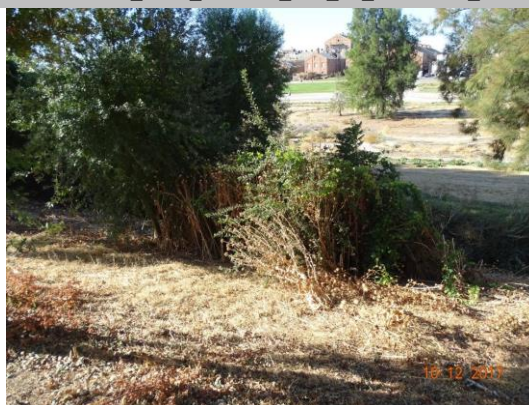
Photo 1 of 1 : SP_2018_RD0999_235_50_20180301_00041.jpg

LM Start	0.85	Rating **	M	Issue No.	50
LM End	0.85	Issue Type +	Ma	Location *	LS
Category	Earthen Levee			GPS Latitude/Longitude	
				Start	End
Item	Vegetation			38.424805 °	38.424805 °
				-121.530541 °	-121.530541 °
DWR ID	DWR_RD0999_04_f_2017_50				
Comment Code					
V2 : Remove the wild growth other than native grasses from the levee slopes.					
Inspector Comment

Looking west at the landside slope.

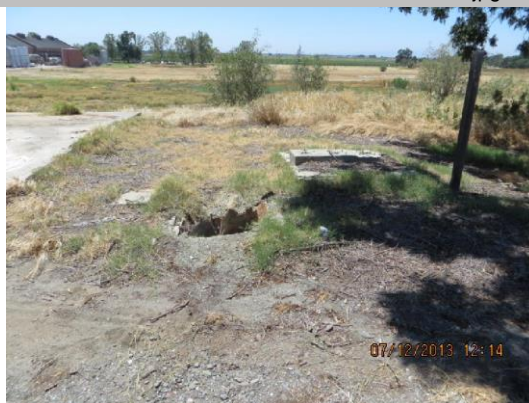
Photo 2 of 3 : UCIP_SP_2018_16385_27654.jpg

Pipe in concrete vault on LS shoulder.

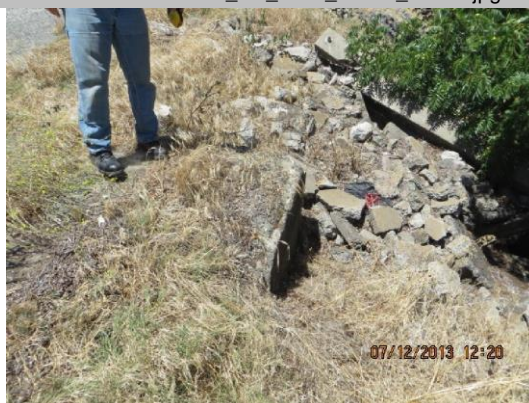
Photo 3 of 3 : UCIP_SP_2018_16385_27653.jpg

Pipe assumed to be in concrete vault on WS shoulder.

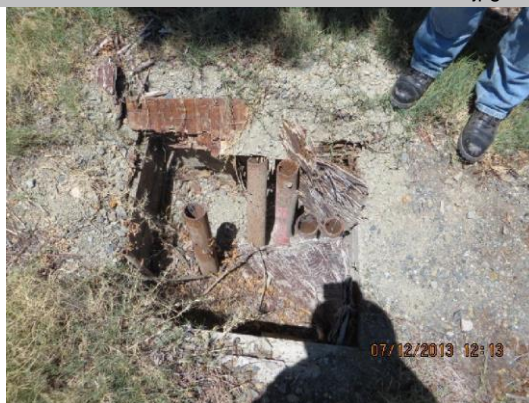
Photo 1 of 3 : UCIP_SP_2018_16386_27661.jpg

LM Start	0.90	Rating **	M	Issue No.	63
LM End	0.90	Issue Type +	En	Location *	
Category	Supplemental			GPS Latitude/Longitude	
				Start	End
Item	DWR UCIP Field Study			38.425514 °	38.425514 °
				-121.530970 °	-121.530970 °
DWR ID					
Comment Code					
Inspector Comment					
FS_ID:16386					
DS_ID:22810					
EP_NO: N/A					
Repair Type: Non-Urgent					
Crossing Status: Found					
UCIP Comments: Pipe abandoned and should be done so properly.					
FIELD_STRUCT_DESC: *ABANDONED* 6 of 6: 3.5-inch pipe of an					
unknown material or purpose through the levee, 2.5 feet below the					
crown. Pipe visible in a concrete well on the landside (LS) shoulder.					
[Additional Reference(s): DWR Levee Log, 1992].					
FS Date: 7/12/2013

Pipes visible in concrete well on LS shoulder.

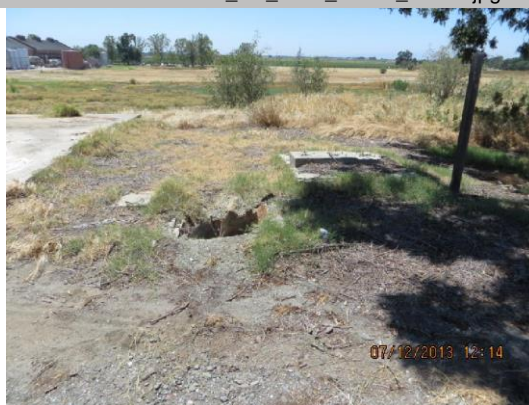
Photo 2 of 3 : UCIP_SP_2018_15728_26188.jpg

LM Start	0.91	Rating **	M	Issue No.	64 (cont)
LM End	0.91	Issue Type +	En	Location *

Pipes visible in concrete well on LS shoulder.

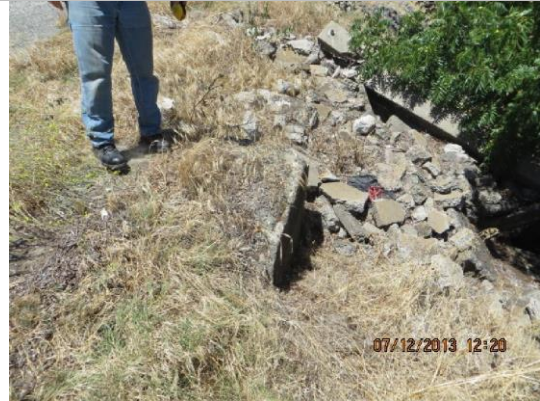
Photo 3 of 3 : UCIP_SP_2018_15728_26187.jpg

LM Start	0.91	Rating **	M	Issue No.	64 (cont)	
LM End	0.91	Issue Type +	En	Location *		
Category	Supplemental			GPS Latitude/Longitude		
				Start		End
Item	DWR UCIP Field Study			38.425514 °		38.425514 °
				-121.530970 °		-121.530970 °
DWR ID						
Comment Code						
Inspector Comment						
FS_ID:15728						
DS_ID:22806						
EP_NO: N/A						
Repair Type: Non-Urgent						
Crossing Status: Found						
UCIP Comments: Pipe abandoned and should be done so properly.						
FIELD_STRUCT_DESC: *ABANDONED* 2 of 6: 3.5-inch pipe of an						
unknown material or purpose through the levee, 2.5 feet below the						
crown. Pipe visible in a concrete well on the landside (LS) shoulder and						
likely in a covered concrete well on the waterside (WS) shoulder.						
[Additional Reference(s): DWR Levee Log, 1992].						
FS Date: 7/12/2013

Assumed pipes are in concrete well on WS shoulder at same location.

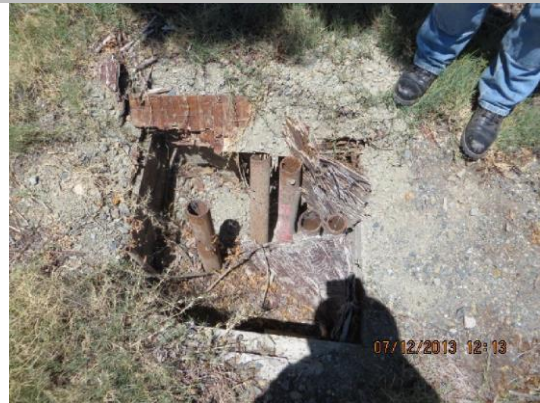
Photo 1 of 3 : UCIP_SP_2018_15727_26186.jpg

LM Start	0.91	Rating **	M	Issue No.	65	
LM End	0.91	Issue Type +	En	Location *		
Category	Supplemental			GPS Latitude/Longitude		
				Start	End	
Item	DWR UCIP Field Study			38.425514 °	38.425514 °	
				-121.530970 °	-121.530970 °	
DWR ID						
Comment Code						
Inspector Comment						
FS_ID:15727						
DS_ID:22799						
EP_NO: N/A						
Repair Type: Non-Urgent						
Crossing Status: Found						
UCIP Comments: Pipes abandoned and should be done so properly.						
FIELD_STRUCT_DESC: *ABANDONED* 1 of 6: 3.5-inch pipe of an						
unknown material or purpose through the levee, 2.5 feet below the						
crown. Pipe visible in a concrete well on the landside (LS) shoulder.						
Concrete well on the waterside (WS) shoulder is visible, but access is						
covered with soil. [Additional Reference(s): DWR Levee Log, 1992].						
FS Date: 7/12/2013

Pipes in concrete well on LS shoulder.

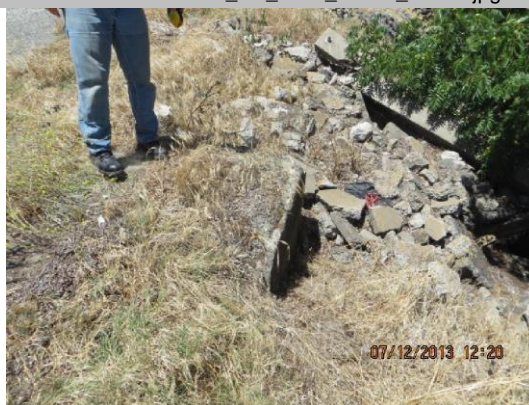
Photo 3 of 3 : UCIP_SP_2018_15727_26184.jpg

LM Start	0.91	Rating **	M	Issue No.	65 (cont)	
LM End	0.91	Issue Type +	En	Location *		
Category	Supplemental			GPS Latitude/Longitude		
				Start	End	
Item	DWR UCIP Field Study			38.425514 °	38.425514 °	
				-121.530970 °	-121.530970 °	
DWR ID						
Comment Code						
Inspector Comment						
FS_ID:15727						
DS_ID:22799						
EP_NO: N/A						
Repair Type: Non-Urgent						
Crossing Status: Found						
UCIP Comments: Pipes abandoned and should be done so properly.						
FIELD_STRUCT_DESC: *ABANDONED* 1 of 6: 3.5-inch pipe of an						
unknown material or purpose through the levee, 2.5 feet below the						
crown. Pipe visible in a concrete well on the landside (LS) shoulder.						
Concrete well on the waterside (WS) shoulder is visible, but access is						
covered with soil. [Additional Reference(s): DWR Levee Log, 1992].						
FS Date: 7/12/2013

Assumed pipes inside concrete well on WS shoulder at same location.

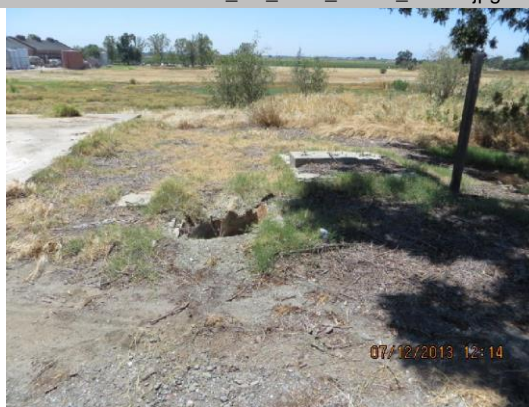
Photo 2 of 3 : UCIP_SP_2018_16384_27648.jpg

Pipe in concrete vault on WS shoulder.

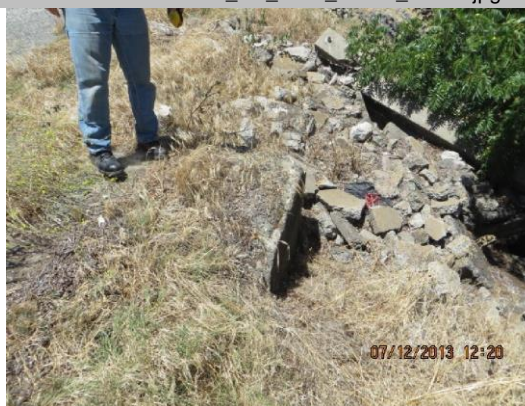
Photo 3 of 3 : UCIP_SP_2018_15733_26195.jpg

LM Start	0.91	Rating **	M	Issue No.	67 (cont)	
LM End	0.91	Issue Type +	En	Location *		
Category	Supplemental			GPS Latitude/Longitude		
				Start	End	
Item	DWR UCIP Field Study			38.425514 °	38.425514 °	
				-121.530970 °	-121.530970 °	
DWR ID						
Comment Code						
Inspector Comment						
FS_ID:15733						
DS_ID:22808						
EP_NO: N/A						
Repair Type: Non-Urgent						
Crossing Status: Found						
UCIP Comments: Pipe abandoned and should be done so properly.						
FIELD_STRUCT_DESC: *ABANDONED* 4 of 6: 3.5-inch pipe of an						
unknown material or purpose through the levee, 2.5 feet below the						
crown. Pipe visible in concrete wells on the landside (LS) and the						
waterside (WS) shoulders. [Additional Reference(s): DWR Levee Log,						
1992].						
FS Date: 7/12/2013

Pipe assumed visible in concrete well on WS shoulder.

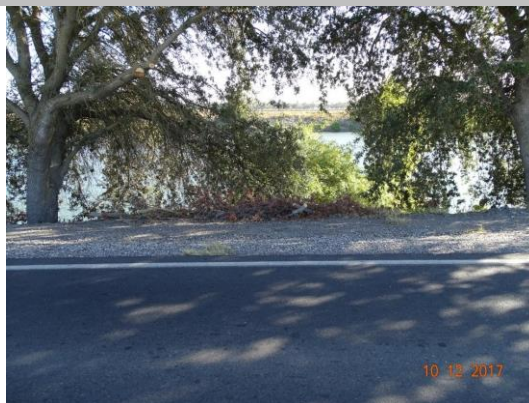
Photo 1 of 1 : SP_2018_RD0999_235_43_20180301_00033.jpg

LM Start	0.94	Rating **	M	Issue No.	43
LM End	0.94	Issue Type +	Ma	Location *	WS
Category	Earthen Levee			GPS Latitude/Longitude	
				Start	End
Item	Encroachments			38.426005 °	38.426005 °
				-121.531382 °	-121.531382 °
DWR ID	DWR_RD0999_04_f_2017_43				
Comment Code					
PR : Prunings					
Inspector Comment					
Pruning piles on waterside slope,

Looking east at the waterside slope.

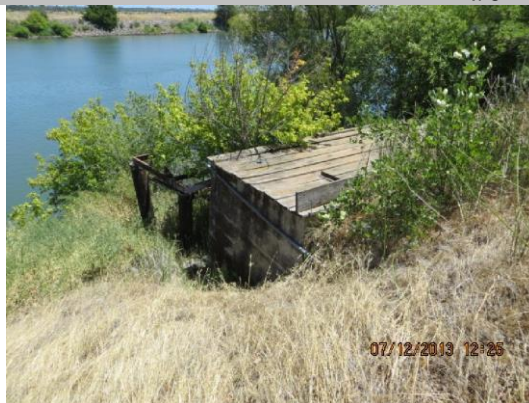
Photo 1 of 3 : UCIP_SP_2018_16387_27664.jpg

Comment Code					
Inspector Comment					
FS_ID:16387 DS_ID:22800 EP_NO: N/A Repair Type: Non-Urgent Crossing Status: Found UCIP Comments: Pipe appears abandoned and should be done so properly. FIELD_STRUCT_DESC: 24-inch steel irrigation pipe through the levee, 13 feet below the crown. Pipe measures 16 inches in diameter on the waterside (WS) and 24 inches in diameter on the landside (LS) toe. Gate valve in a 9-foot by 18-foot concrete well on the WS slope. Slant pump missing from the WS slope. Concrete distribution house/box at the LS toe. 1.5-inch galvanized iron electrical conduit at the same location. [Additional Reference(s): DWR Levee Log, 1992. USACE Sacramento O&M Manual 113 (Revised), October 1966, (HLM 0.99)]. FS Date: 7/12/2013

Slide gate in 9'X18' concrete box on WS slope.

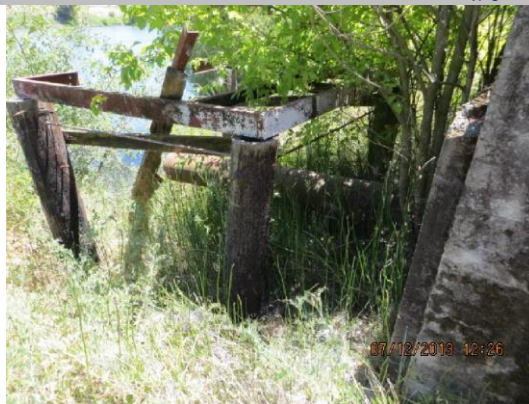
Photo 2 of 3 : UCIP_SP_2018_16387_27663.jpg

Slant pump missing from pier on WS slope.

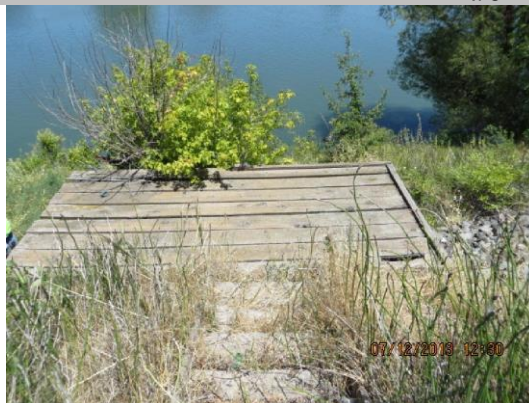
Photo 3 of 3 : UCIP_SP_2018_16387_27662.jpg

Comment Code						
Inspector Comment						
FS_ID:16387 DS_ID:22800 EP_NO: N/A Repair Type: Non-Urgent Crossing Status: Found UCIP Comments: Pipe appears abandoned and should be done so properly. FIELD_STRUCT_DESC: 24-inch steel irrigation pipe through the levee, 13 feet below the crown. Pipe measures 16 inches in diameter on the waterside (WS) and 24 inches in diameter on the landside (LS) toe. Gate valve in a 9-foot by 18-foot concrete well on the WS slope. Slant pump missing from the WS slope. Concrete distribution house/box at the LS toe. 1.5-inch galvanized iron electrical conduit at the same location. [Additional Reference(s): DWR Levee Log, 1992. USACE Sacramento O&M Manual 113 (Revised), October 1966, (HLM 0.99)]. FS Date: 7/12/2013

9'X18' concrete box with gatevalve on WS slope.

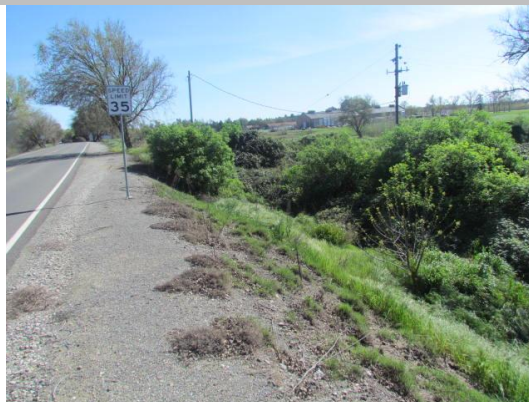
Photo 1 of 4 : SP_2018_RD0999_235_16_20180301_00014.jpg

LM Start	1.01	Rating **	U	Issue No.	16
LM End	1.04	Issue Type +	Ma	Location *	LS
Category	Earthen Levee			GPS Latitude/Longitude	
				Start	End
Item	Vegetation			38.426873 °	38.427295 °
				-121.531778 °	-121.532164 °
DWR ID	DWR_RD0999_04_f_2012_16				
Comment Code					
V2 : Remove the wild growth other than native grasses from the levee slopes.					
Inspector Comment					
Blackberries blocking view of landside toe.

Looking southwest at dense vegetation on landward slope and toe.
(Spring 2016)

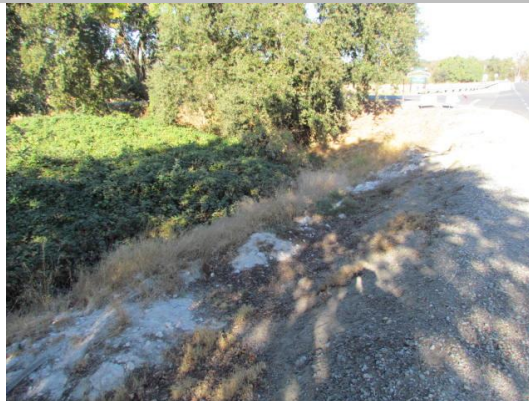
Photo 2 of 4 : SP_2018_RD0999_235_16_20180301_00015.jpg

Looking northwest at dense vines at landward toe. Fall 2015

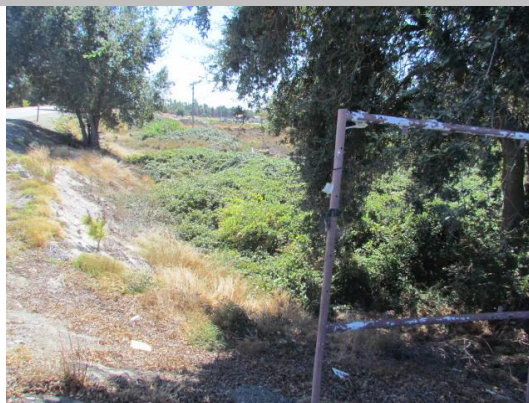
Photo 3 of 4 : SP_2018_RD0999_235_16_20180301_00016.jpg

Looking southwest at dense berry vines at landward toe. 2013

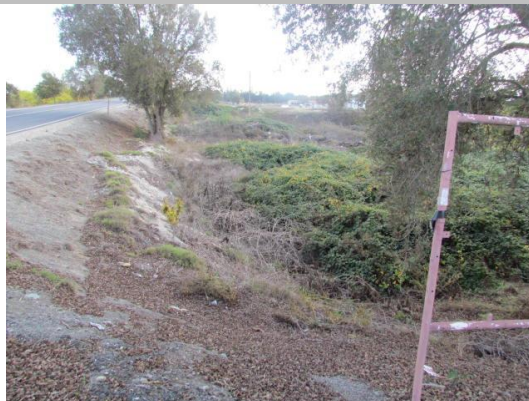
Photo 4 of 4 : SP_2018_RD0999_235_16_20180301_00017.jpg

Looking south at dense berryvines on landside toe. 2012

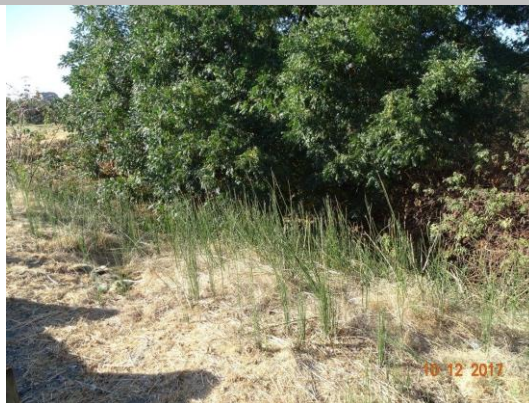
Photo 1 of 3 : SP_2018_RD0999_235_5_20180301_00003.jpg

Looking south at the dense vegetation on the landside slope.

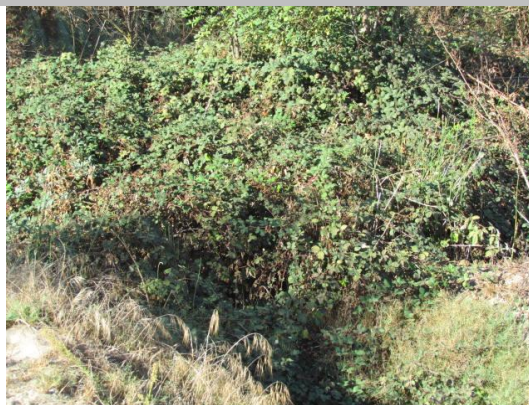
Photo 2 of 3 : SP_2018_RD0999_235_5_20180301_00004.jpg

Looking at dense vines at landward toe. Fall 2015.

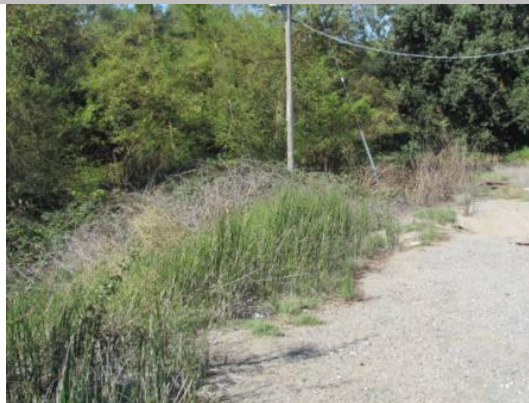
Photo 3 of 3 : SP_2018_RD0999_235_5_20180301_00005.jpg

Looking north at dense vegetation on landside slope near ramp.

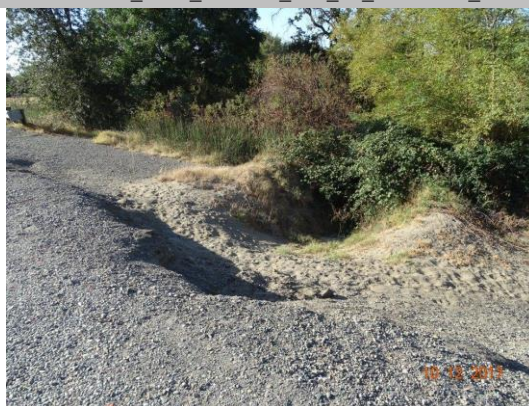
Photo 1 of 3 : SP_2018_RD0999_235_40_20180301_00027.jpg

LM Start	1.16	Rating **	U	Issue No.	40
LM End	1.16	Issue Type +	Ma	Location *	LS
Category	Earthen Levee			GPS Latitude/Longitude	
				Start	End
Item	Erosion / Bank Caving			38.428877 °	38.428877 °
				-121.532922 °	-121.532922 °
DWR ID	DWR_RD0999_04_f_2015_40				
Comment Code					
E2 : Schedule repair of erosion site prior to the next inspection.					
Inspector Comment					
Large hole and erosion on landside shoulder, slope and toe.

Looking southwest at the landside slope.

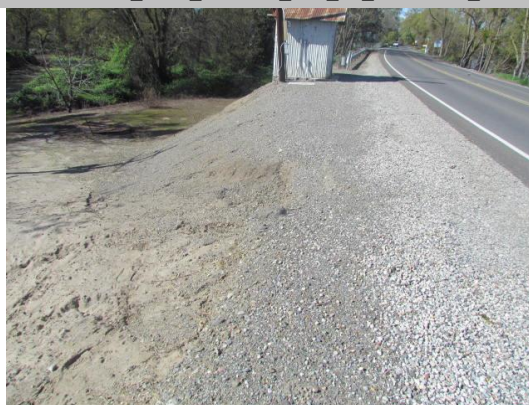
Photo 2 of 3 : SP_2018_RD0999_235_40_20180301_00028.jpg

Looking east at erosion on landward shoulder and slope. (Spring 2016)

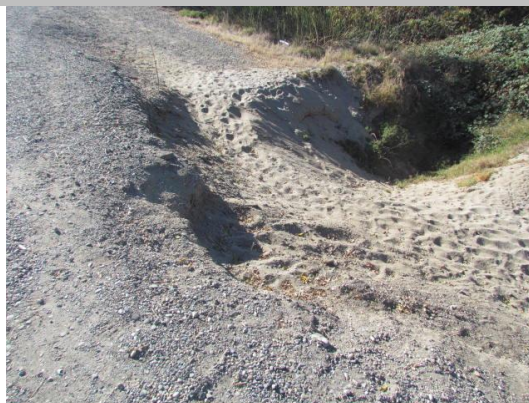
Photo 3 of 3 : SP_2018_RD0999_235_40_20180301_00029.jpg

Looking southwest at shoulder erosion and caving at landward slope and toe.

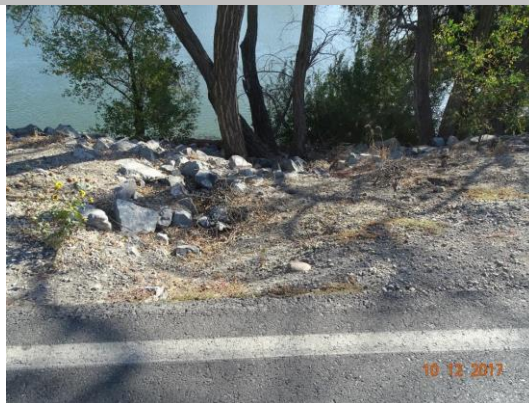
Photo 1 of 2 : SP_2018_RD0999_235_46_20180301_00036.jpg

LM Start	1.18	Rating **	M	Issue No.	46
LM End	1.18	Issue Type +	Ma	Location *	WS
Category	Earthen Levee			GPS Latitude/Longitude	
				Start	End
Item	Erosion / Bank Caving			38.429201 °	38.429201 °
				-121.533012 °	-121.533012 °
DWR ID	DWR_RD0999_04_s_2016_46				
Comment Code					
E2 : Schedule repair of erosion site prior to the next inspection.					
Inspector Comment					
Erosion located just below asphalt on waterside shoulder.

Looking east at the erosion on the waterside slope.

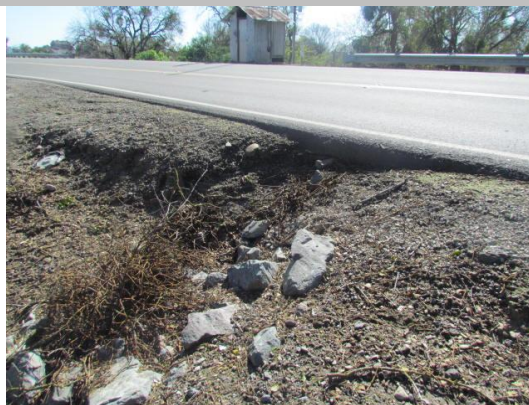
Photo 2 of 2 : SP_2018_RD0999_235_46_20180301_00037.jpg

Looking west at foot erosion on waterward shoulder and slope.

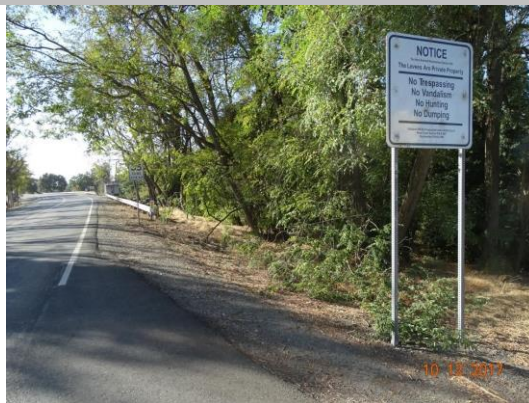
Photo 1 of 2 : SP_2018_RD0999_235_22_20180301_00020.jpg

LM Start	1.20	Rating **	M	Issue No.	22
LM End	1.22	Issue Type +	Ma	Location *	LS
Category	Earthen Levee			GPS Latitude/Longitude	
				Start	End
Item	Trim / Thin Trees			38.429467 °	38.429750 °
				-121.533110 °	-121.533188 °
DWR ID	DWR_RD0999_04_f_2013_22				
Comment Code					
T3 : Trim and thin trees to allow visibility of the ground and room to flood fight.					
Inspector Comment

Looking south at dense trees on landside slope.

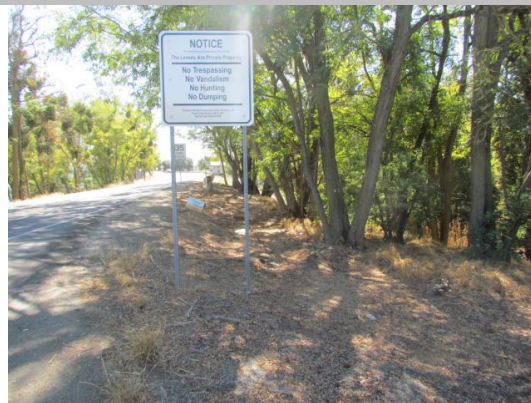
Photo 2 of 2 : SP_2018_RD0999_235_22_20180301_00021.jpg

LM Start	1.20	Rating **	M	Issue No.	22 (cont)	
LM End	1.22	Issue Type +	Ma	Location *	LS	
Category	Earthen Levee			GPS Latitude/Longitude		
				Start		End
Item	Trim / Thin Trees			38.429467 °		38.429750 °
				-121.533110 °		-121.533188 °
DWR ID	DWR_RD0999_04_f_2013_22					
Comment Code						
T3 : Trim and thin trees to allow visibility of the ground and room to flood fight.						
Inspector Comment

Looking south at dense trees on landward slope.

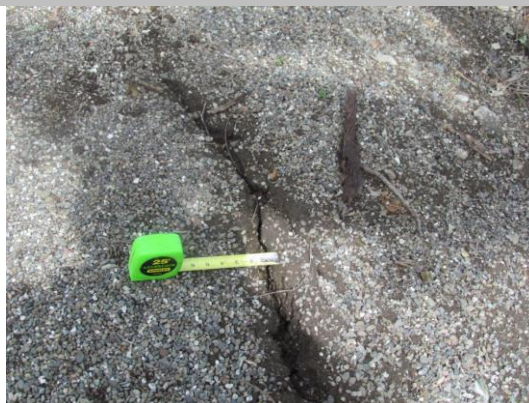
Photo 1 of 3 : SP_2018_RD0999_236_165_20180301_00080.jpg

LM Start	0.11	Rating **	M	Issue No.	165
LM End	0.12	Issue Type +	Ma	Location *	WS
Category	Earthen Levee			GPS Latitude/Longitude	
				Start	End
Item	Slope Stability			38.334198 °	38.334327 °
				-121.584308 °	-121.584275 °
DWR ID	DWR_RD0999_05_s_2017_165				
Comment Code					
S1 : Repair slope instability.					
Inspector Comment					
Crack greater than two inches along top of half of waterward slope. Three dead trees along slope damage section. Trees should be removed.

Looking at two inch plus crack on waterward shoulder.

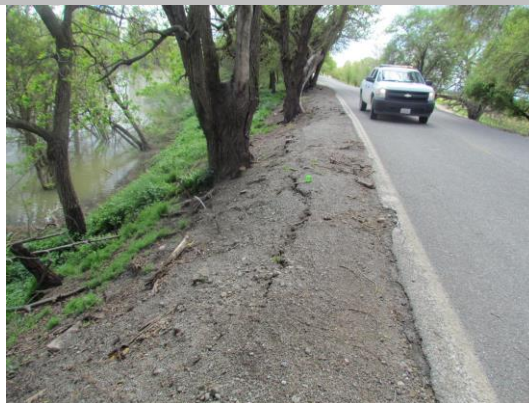
Photo 3 of 3 : SP_2018_RD0999_236_165_20180301_00082.jpg

LM Start	0.11	Rating **	M	Issue No.	165 (cont)	
LM End	0.12	Issue Type +	Ma	Location *	WS	
Category	Earthen Levee			GPS Latitude/Longitude		
				Start		End
Item	Slope Stability			38.334198 °		38.334327 °
				-121.584308 °		-121.584275 °
DWR ID	DWR_RD0999_05_s_2017_165					
Comment Code						
S1 : Repair slope instability.						
Inspector Comment						
Crack greater than two inches along top of half of waterward slope. Three dead trees along slope damage section. Trees should be removed.

Looking downstream at crack along waterward shoulder.

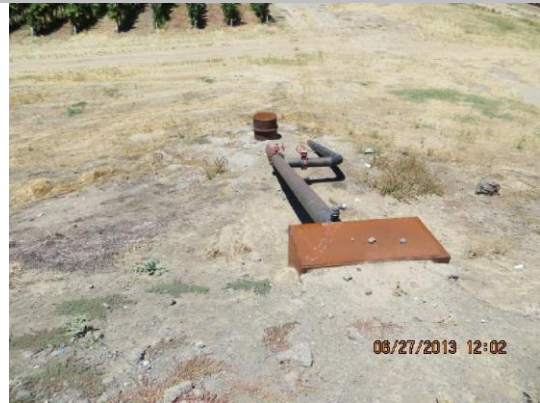
Photo 3 of 3 : UCIP_SP_2018_15411_25293.jpg

Comment Code					
Inspector Comment					
FS_ID:15411 DS_ID:22839 EP_NO: N/A Repair Type: Non-Urgent Crossing Status: Found UCIP Comments: Walkway to pump on pier is falling appart and should be removed. FIELD_STRUCT_DESC: 12-inch steel irrigation pipe through the levee, 11 feet below the crown. 10-inch pipe visible on slopes and at slant pump on the waterside (WS) slope. Pump on structure removed. Additional slant pump on the WS slope ties into pipe. 30-inch steel standpipe on the landside (LS) toe. Butterfly valves located on both sides of the levee. 3-foot by 3-foot steel junction box on the WS shoulder, and a 31-inch by 60-inch steel junction box on the LS shoulder. Service poles on both slopes. [Additional Reference(s): DWR Levee Log, 1992. USACE Sacramento O&M Manual 113 (Revised), October 1966, (HLM 0.23)]. FS Date: 6/27/2013

Steel junction box, vent, butterfly valve, and standpipe visible on LS slope.

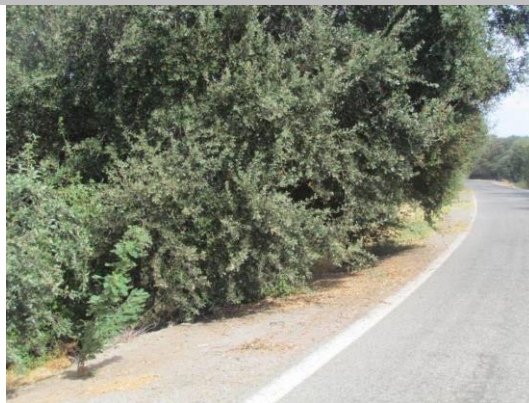
Photo 1 of 2 : SP_2018_RD0999_236_8_20180301_00005.jpg

LM Start	0.37	Rating **	M	Issue No.	8 (cont)
LM End	0.42	Issue Type +	Ma	Location *	LS

Looking northwest at dense vegetation on landward slope. (Fall 2016)

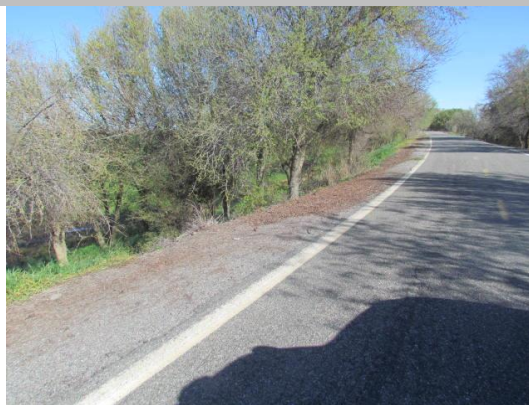
Photo 2 of 2 : SP_2018_RD0999_236_8_20180301_00006.jpg

Looking northwest at dense vegetation on landward slope. (Spring 2016)

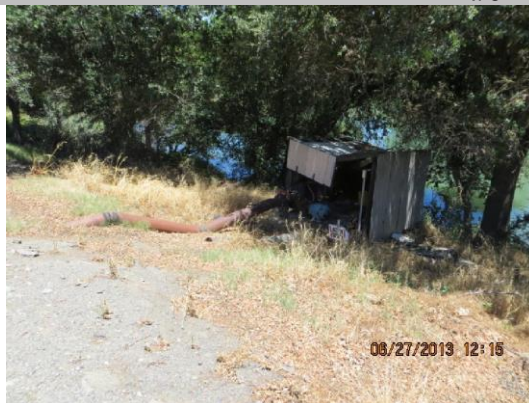
Photo 1 of 3 : UCIP_SP_2018_15413_25304.jpg

LM Start	0.50	Rating **	M	Issue No.	230
LM End	0.50	Issue Type +	En	Location *	
Category	Supplemental			GPS Latitude/Longitude	
				Start	End
Item	DWR UCIP Field Study			38.339607 °	38.339607 °
				-121.582091 °	-121.582091 °
DWR ID					
Comment Code					
Inspector Comment					
FS_ID:15413 DS_ID:22840 EP_NO: 6081 Repair Type: Non-Urgent Crossing Status: Found UCIP Comments: Some settlement along LS and WS slopes. Good candidates for video inspection. FIELD_STRUCT_DESC: 10-inch steel irrigation pipe through the levee, 3.3 feet below the crown. Pump and butterfly valve in pump house on the waterside (WS) slope. Vent in 10-inch steel standpipe on the landside (LS) slope. (Replaced an existing 10-inch pipe under Permit No. 6081, 1968 - George M. Hiromoto). [Additional Reference(s): DWR Levee Log, 1992]. FS Date: 6/27/2013

Pump in pumphouse on WSs slope.

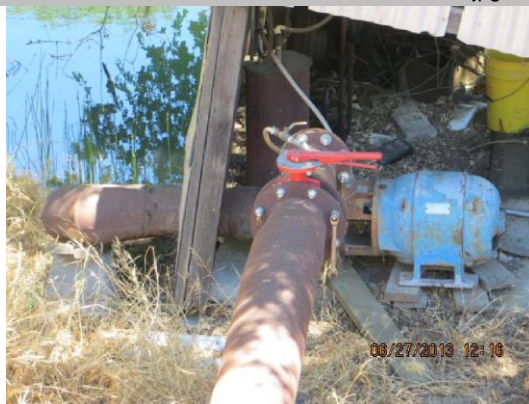
Photo 2 of 3 : UCIP_SP_2018_15413_25303.jpg

LM Start	0.50	Rating **	M	Issue No.	230 (cont)
LM End	0.50	Issue Type +	En	Location *

Butterfly valve at pumphouse on WS slope.

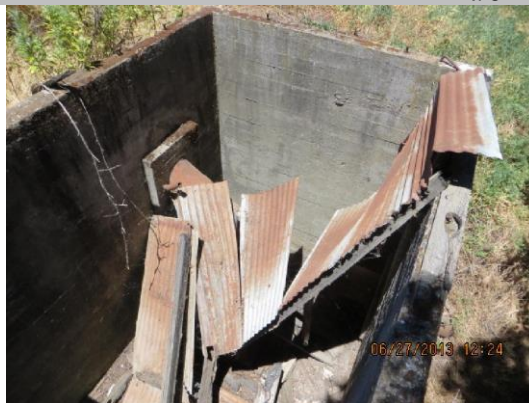
Photo 1 of 3 : UCIP_SP_2018_15414_25308.jpg

LM Start	0.58	Rating **	M	Issue No.	231
LM End	0.58	Issue Type +	En	Location *	
Category	Supplemental			GPS Latitude/Longitude	
				Start	End
Item	DWR UCIP Field Study			38.340651 °	38.340651 °
				-121.581861 °	-121.581861 °
DWR ID					
Comment Code					
Inspector Comment					
FS_ID:15414					
DS_ID:22841					
EP_NO: N/A					
Repair Type: Non-Urgent					
Crossing Status: Found					
UCIP Comments: Pipe abandoned and should be done so properly.					
FIELD_STRUCT_DESC: *ABANDONED* 16-inch steel irrigation pipe					
through the levee, 6 feet below the crown. Concrete pump house on the					
waterside (WS) slope. [Additional Reference(s): DWR Levee Log, 1992.					
USACE Sacramento O&M Manual 113 (revision), October 1966, (HLM					
0.61)].					
FS Date: 6/27/2013

Pipe visible inside abandoned pumphouse on WS slope.

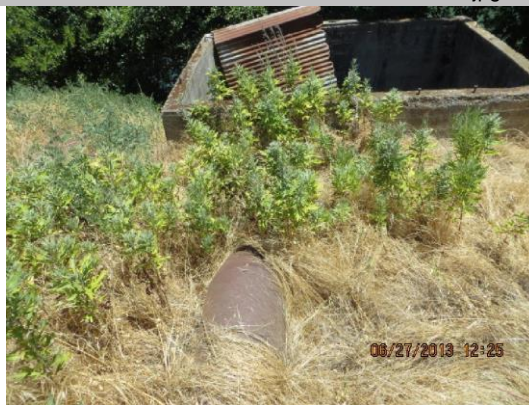
Photo 2 of 3 : UCIP_SP_2018_15414_25307.jpg

LM Start	0.58	Rating **	M	Issue No.	231 (cont)
LM End	0.58	Issue Type +	En	Location *

Pipe visible on WS slope.

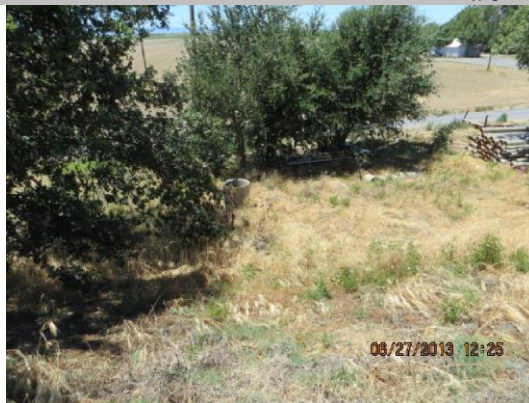
Photo 3 of 3 : UCIP_SP_2018_15414_25306.jpg

LM Start	0.58	Rating **	M	Issue No.	231 (cont)	
LM End	0.58	Issue Type +	En	Location *		
Category	Supplemental			GPS Latitude/Longitude		
				Start	End	
Item	DWR UCIP Field Study			38.340651 °	38.340651 °	
				-121.581861 °	-121.581861 °	
DWR ID						
Comment Code						
Inspector Comment						
FS_ID:15414						
DS_ID:22841						
EP_NO: N/A						
Repair Type: Non-Urgent						
Crossing Status: Found						
UCIP Comments: Pipe abandoned and should be done so properly.						
FIELD_STRUCT_DESC: *ABANDONED* 16-inch steel irrigation pipe						
through the levee, 6 feet below the crown. Concrete pump house on the						
waterside (WS) slope. [Additional Reference(s): DWR Levee Log, 1992.						
USACE Sacramento O&M Manual 113 (revision), October 1966, (HLM						
0.61)].						
FS Date: 6/27/2013

Pipe may be aligned with concrete standpipe at LS toe, but no pipe is visible on LS.

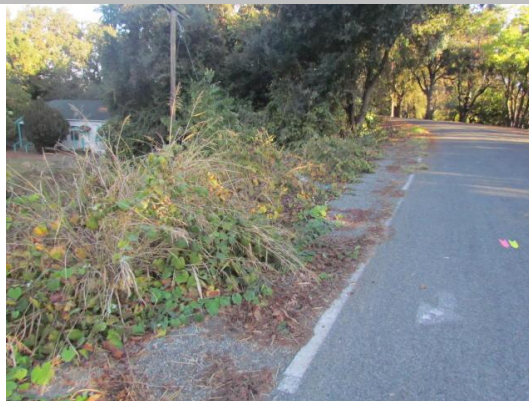
Photo 2 of 2 : SP_2018_RD0999_236_189_20180301_00104.jpg

LM Start	0.68	Rating **	M	Issue No.	189 (cont)
LM End	0.68	Issue Type +	Ma	Location *	LS

Looking northwest at dense vegetation on landward slope. (Spring 2016)

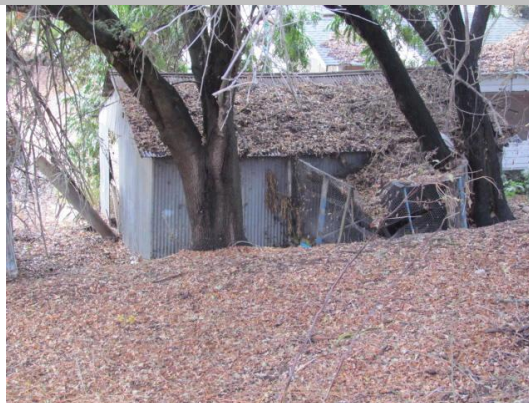
Photo 1 of 1 : SP_2018_RD0999_236_170_20180301_00090.jpg

LM Start	0.70	Rating **	U	Issue No.	170
LM End	0.70	Issue Type +	En	Location *	LS
Category	Earthen Levee			GPS Latitude/Longitude	
				Start	End
Item	Encroachments			38.342288 °	38.342288 °
				-121.581278 °	-121.581278 °
DWR ID	DWR_RD0999_05_f_2015_170				
Comment Code					
BU : Building					
Inspector Comment					
Toolshed at landside toe.

Looking at the toolshed at the landward toe.

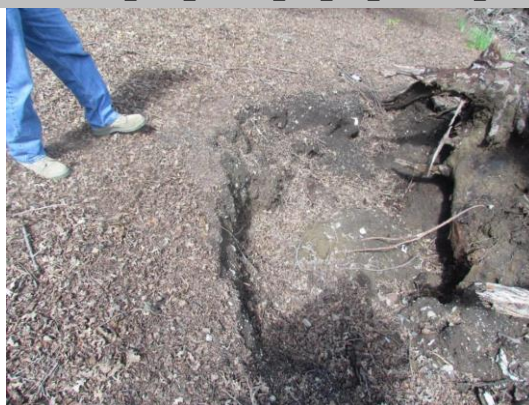
Photo 1 of 3 : SP_2018_RD0999_236_166_20180301_00083.jpg

LM Start	0.71	Rating **	U	Issue No.	166
LM End	0.71	Issue Type +	Ma	Location *	WS
Category	Earthen Levee			GPS Latitude/Longitude	
				Start	End
Item	Encroachments			38.342483 °	38.342483 °
				-121.581235 °	-121.581235 °
DWR ID	DWR_RD0999_05_s_2017_166				
Comment Code					
TR : Tree or limb					
Inspector Comment					
Dead tree fallen on waterward slope. Root ball Left hole on waterward slope 10 to 12 inches deep and approximately 5-ft in diameter.

Looking at hole left by fallen tree on waterward slope.

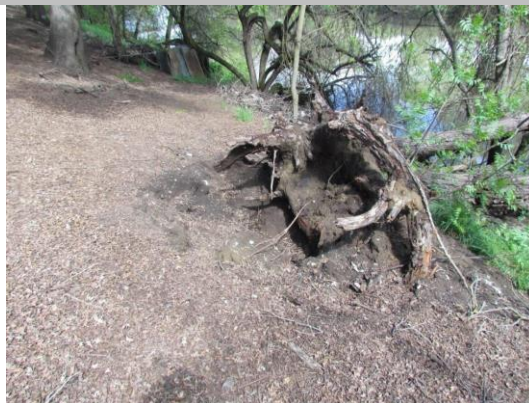
Photo 2 of 3 : SP_2018_RD0999_236_166_20180301_00084.jpg

LM Start	0.71	Rating **	U	Issue No.	166 (cont)
LM End	0.71	Issue Type +	Ma	Location *	WS

Looking east at fallen tree on waterward slope.

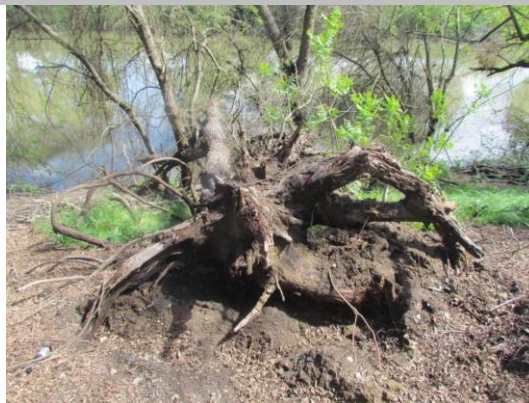
Photo 3 of 3 : SP_2018_RD0999_236_166_20180301_00085.jpg

LM Start	0.71	Rating **	U	Issue No.	166 (cont)	
LM End	0.71	Issue Type +	Ma	Location *	WS	
Category	Earthen Levee			GPS Latitude/Longitude		
				Start		End
Item	Encroachments			38.342483 °		38.342483 °
				-121.581235 °		-121.581235 °
DWR ID	DWR_RD0999_05_s_2017_166					
Comment Code						
TR : Tree or limb						
Inspector Comment						
Dead tree fallen on waterward slope. Root ball Left hole on waterward slope 10 to 12 inches deep and approximately 5-ft in diameter.

Looking downstream at fallen tree on waterward slope.
